GLENCORE

**Westside Open Cut
rehabilitation and Oceanic Coal complex
mine closure update**

March 2017

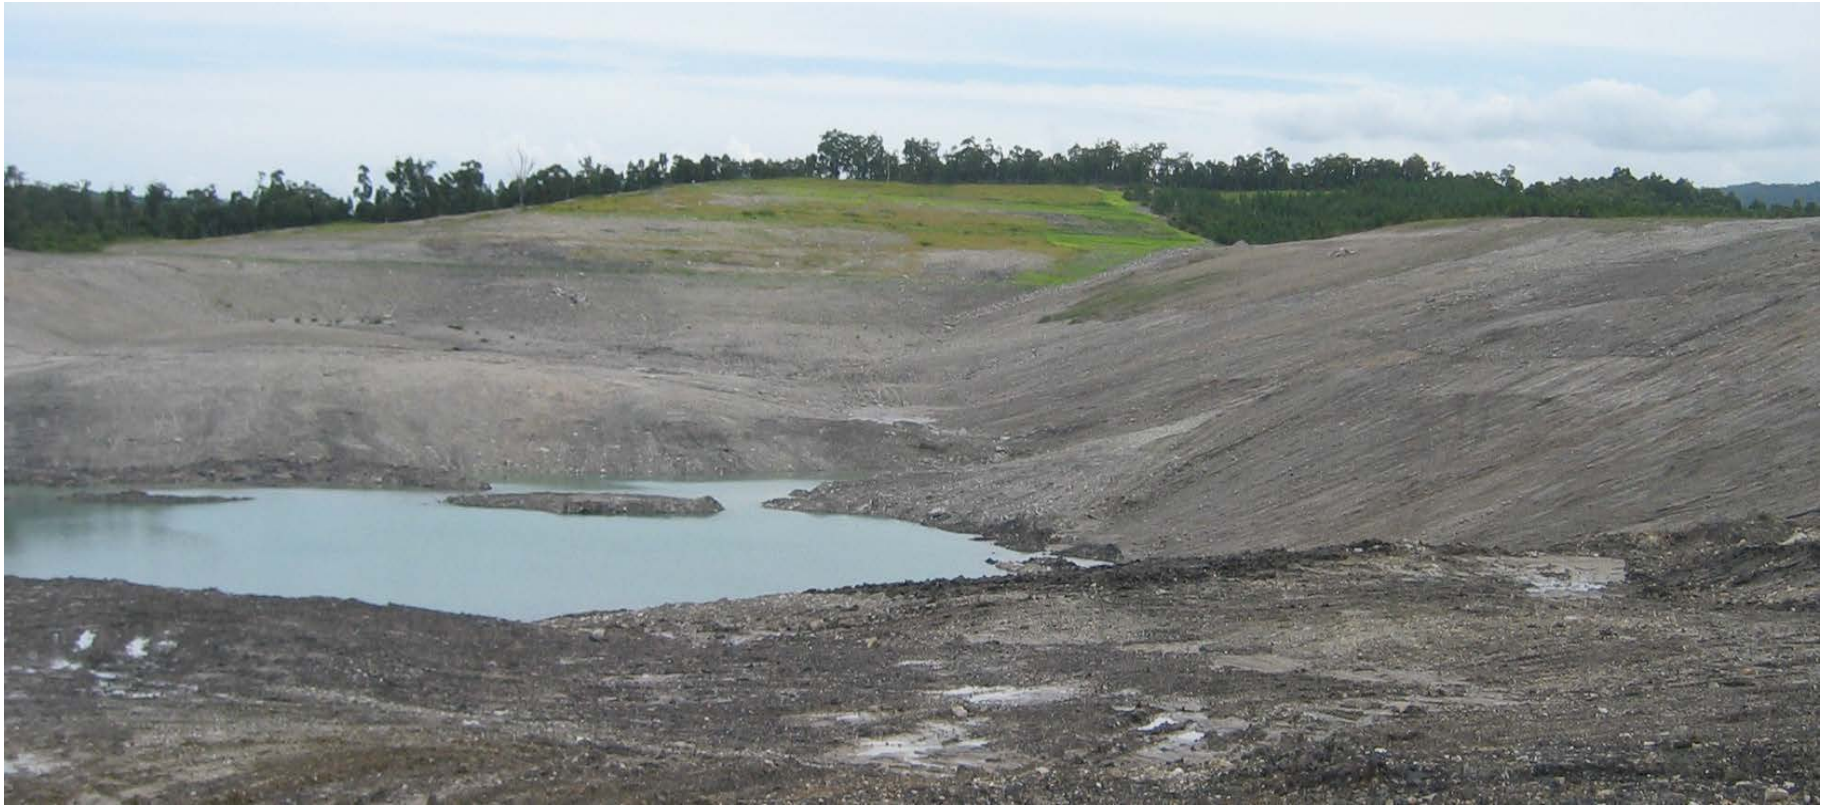
Completed in 2012

The 'highwall' of the final void has overburden placed against it

- Reduces long term safety risks
- Reduces long term geotech risks

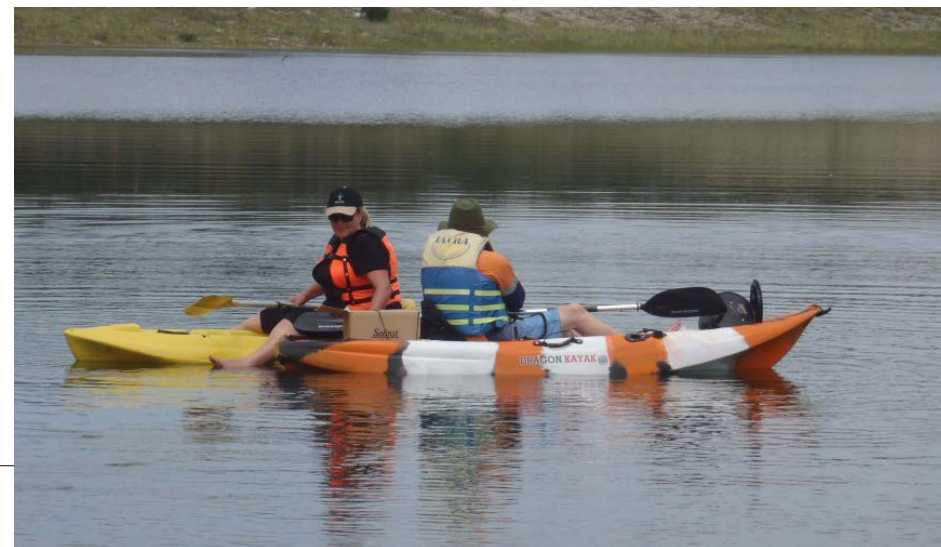
- Current water volume 1696ML (Reduced level of 5m)
- Regular survey and water quality monitoring
- Increase in RL to 12.5 (7.5m higher then current)
- Final volume of 3.4 GL
- Periodically spill from 2029 (estimate) to Cockle creek
- Water quality expected to meet Environmental Protection Licence discharge criteria
