# MANAGING PIT LAKE WATER QUALITY

## PT ADARO INDONESIA

# Resume of Characteristics of Paringin Pit Lake

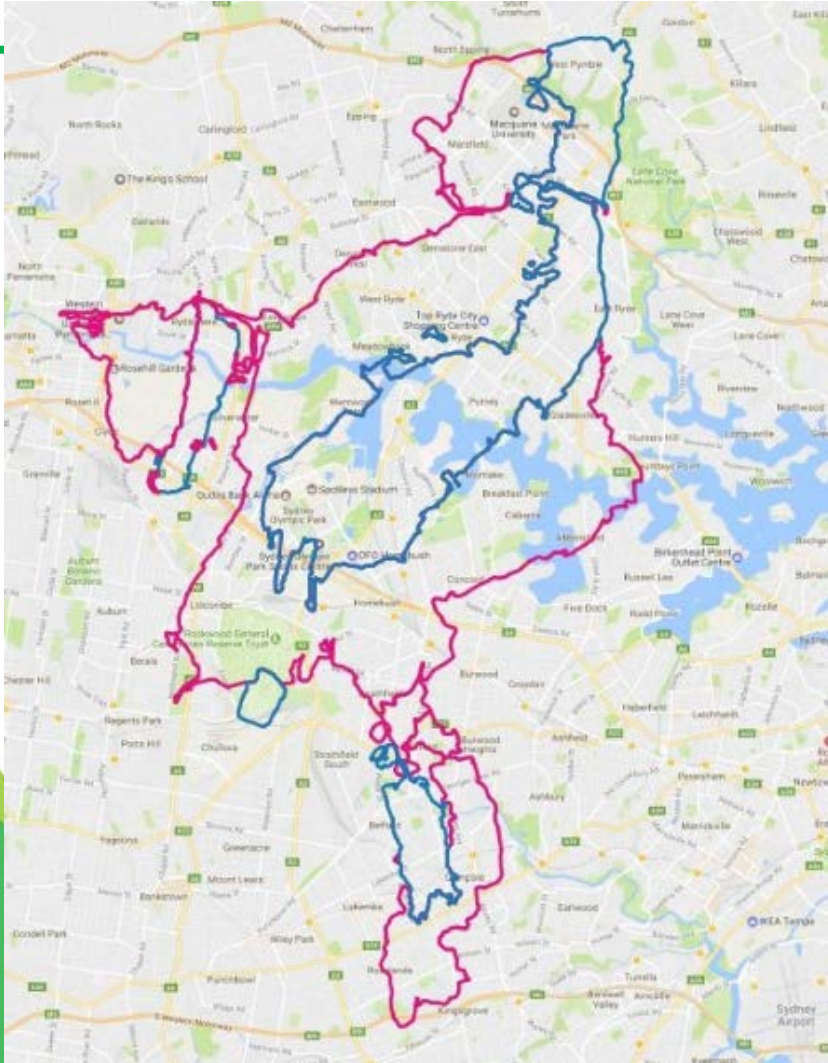
# PT Adaro Indonesia Active Area vs Sydney Area

PT Adaro Indonesia Active area is 15,000 ha out of 35,000,000 ha concession area for mine pit and waste dump/overburden disposal area

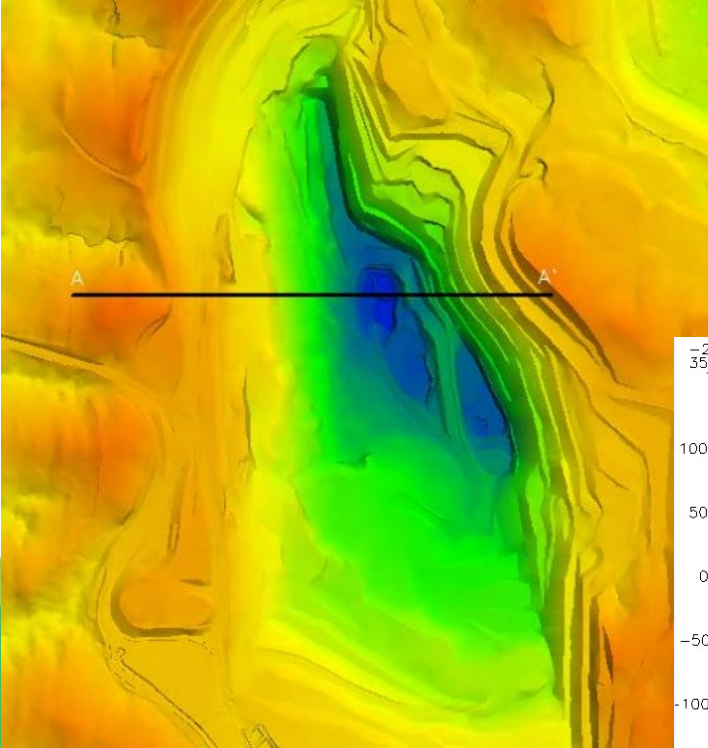
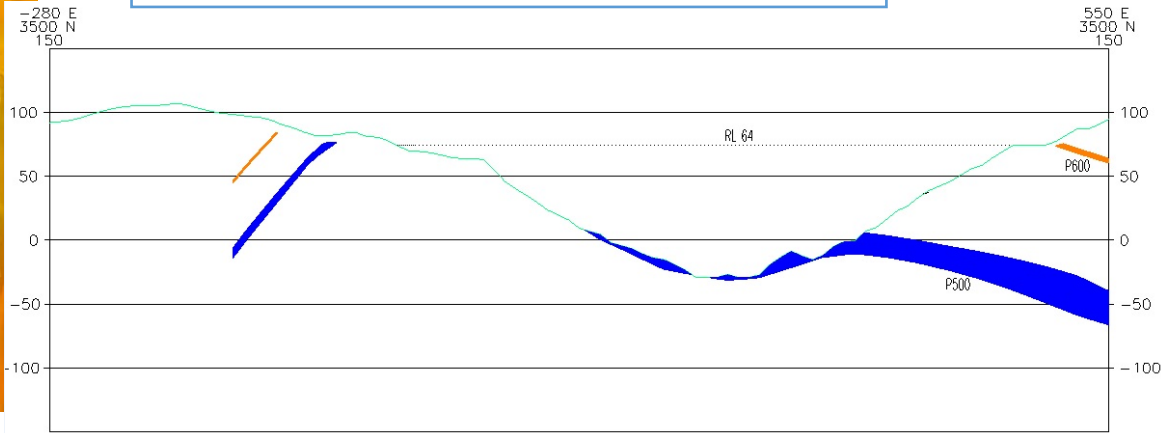
# Pit Lake Geometry

90 m of water depth

Surface water level at 64 m asl

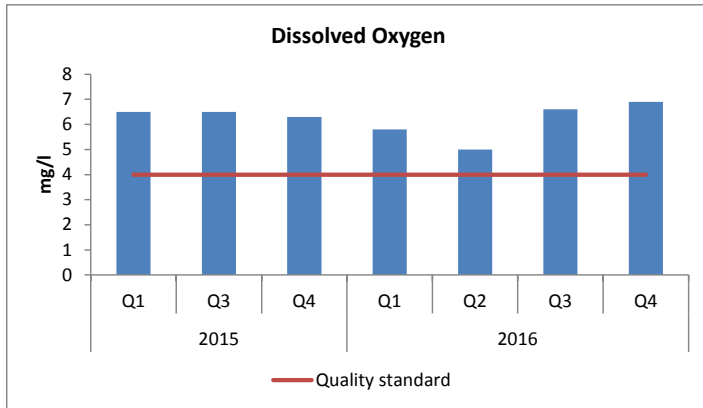
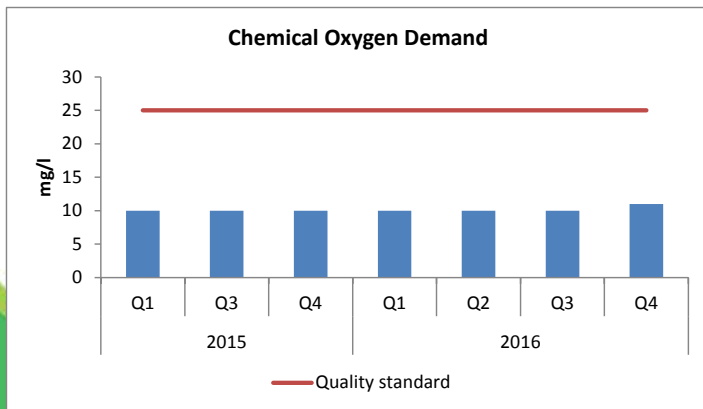
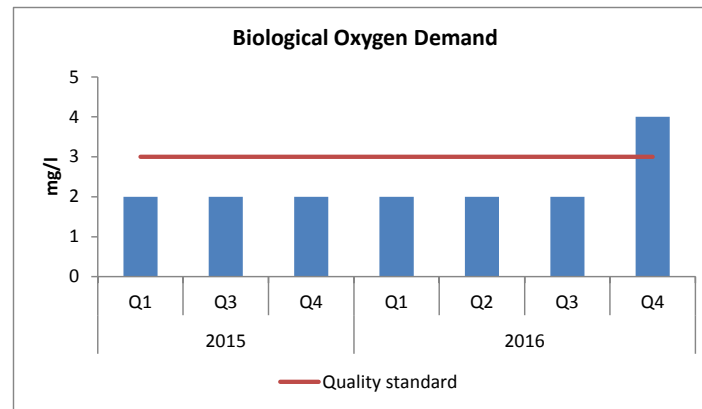
# 2015-2016 Quarterly DO, COD and BOD of Paringin Pit Lake

Good Dissolved Oxygen above 4mg/l  
COD below 25 mg/l  
BOD below 3 mg/l (except Q4)

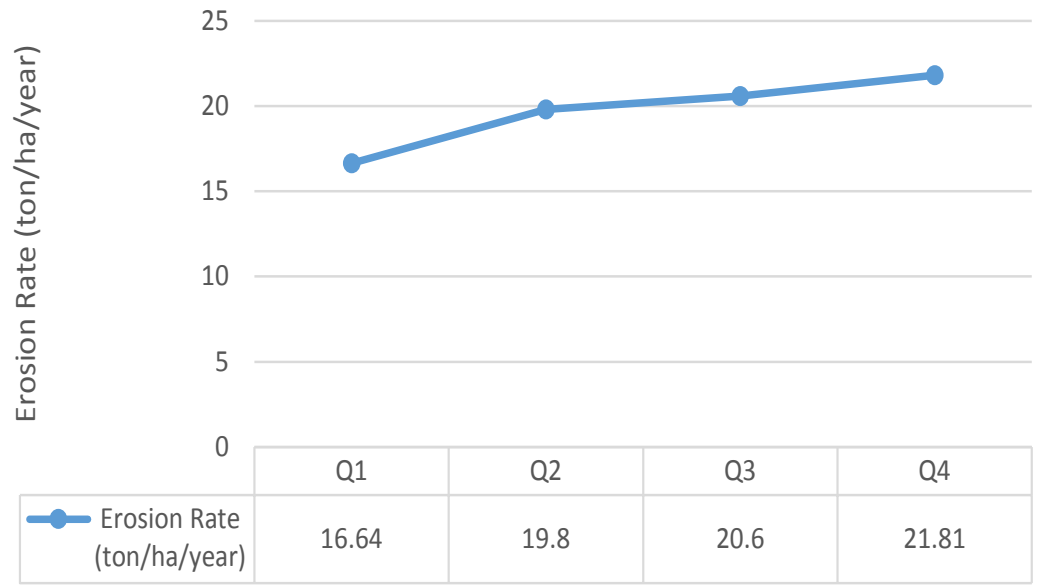
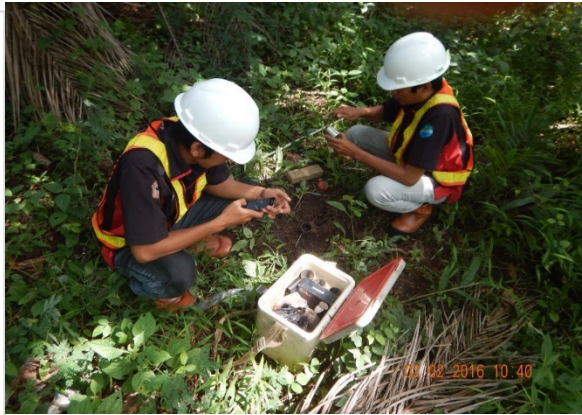
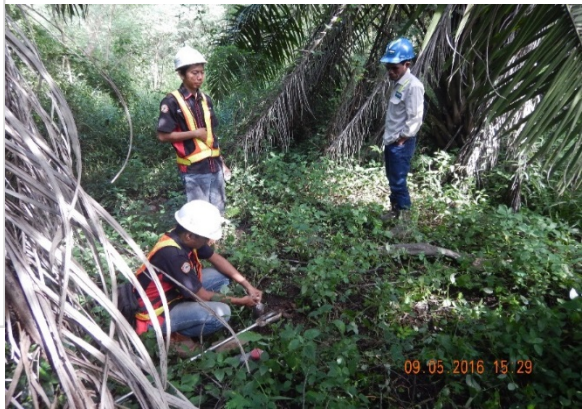
# Low Erosion Rate of Rehabilitated/ Revegetated Area

Erosion Rate Rehabilitated Area Paringin Pit Lake Catchment 2016 (ton/ha/year)

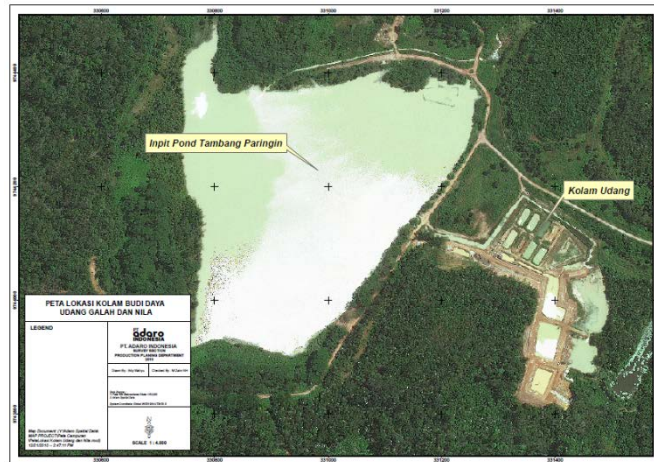
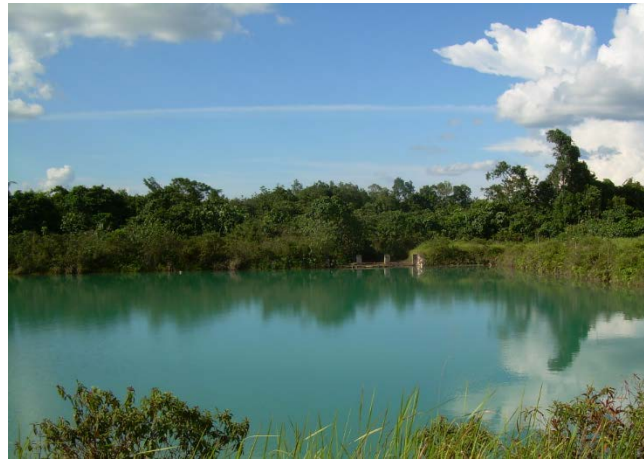
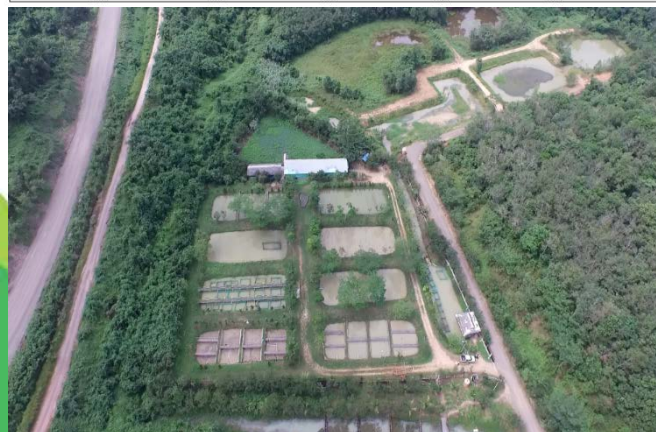
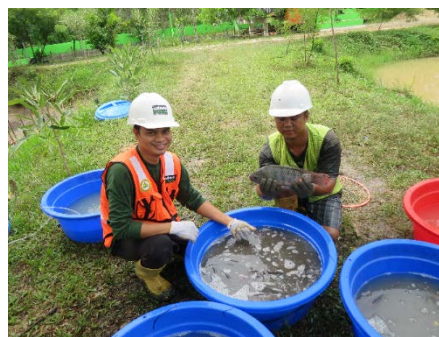
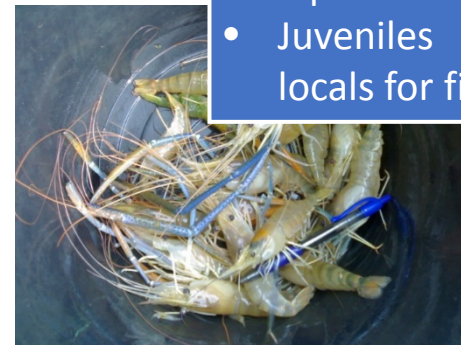
# Paringin Pit Lake Water Used : Fish Farm

- Total area of ponds : 1.5 Ha. Flow through water +/- 900,000 m<sup>3</sup>/month
- 8 fish ponds with dimension : 35 x 15 x 1,5 (depth) m
- 3 ponds for fish mating with 300 males and 900 females.
- 2 ponds for growing fish
- Juveniles are sent to locals for fish farming.
