Restoring Erosional Features in the Desert New Landform Design Software and Automated Machine Guidance Combine in Award-Winning Reclamation Project

Sands Mine in Wisconsin (US) in humid, temperate environment

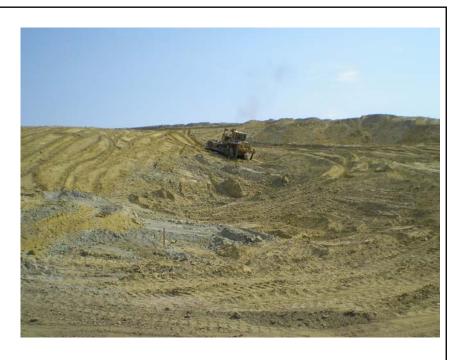
D9 dozer equipped with machine control GPS shaping "A" channel

Abandoned Mine Lands Project 16 N-3 rehabilitated with GeoFluv - Natural Regrade. Images from Harold Hutson, **Project Engineer, BRS** Inc.- Engineering Consultants, Wyoming, US

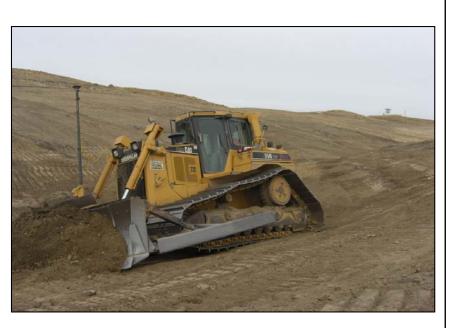
D9 dozer equipped with machine control GPS shaping "A" channel

Abandoned Mine Lands Project 17 H-2B (Wyoming, US) rehabilitated with GeoFluv – Natural Regrade. Images from Harold Hutson, Project Engineer, BRS Inc.- Engineering Consultants, Wyoming, US

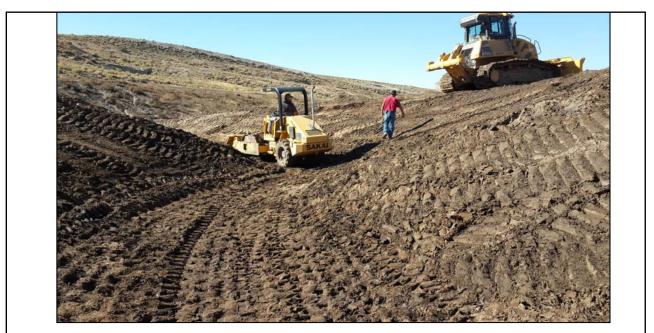
Abandoned Mine Lands Project Lionkol (Wyoming, US) rehabilitated with GeoFluv – Natural Regrade. Images from Harold Hutson, Project Engineer, BRS Inc.- Engineering Consultants, Wyoming, US

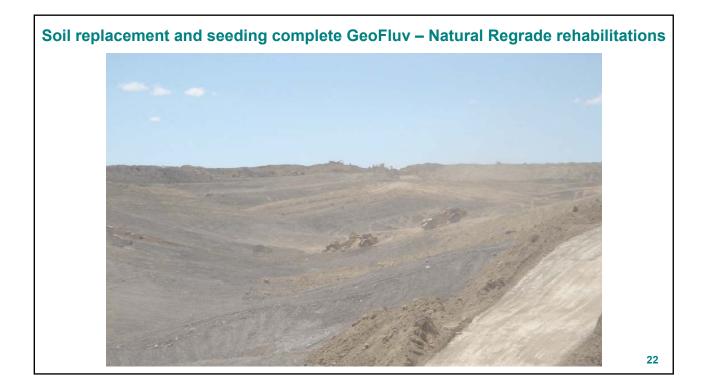
Experiment preparation for sediment yield monitoring

Earth dams construction at La Plata, New México.

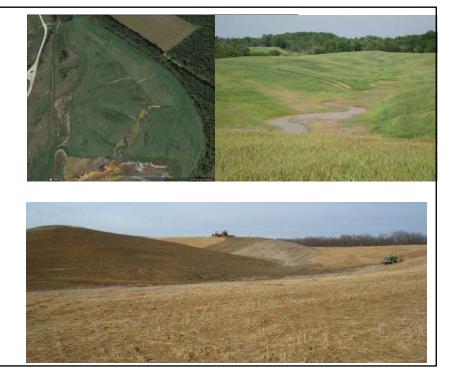
This sand mine in northern Wisconsin has erodible sands that for many years led to maintenance and repair of traditional slope reclamation. The earth material properties, clean and loose sand particles made very difficult to reclaim with stability against erosion using traditional reclamation methods. GeoFluv – Natural Regrade designs have passed heavy storms without requiring repair. The reclamation designed also blends into the surroundings providing additional benefit at no additional cost.

Example of physical and chemical stabilization

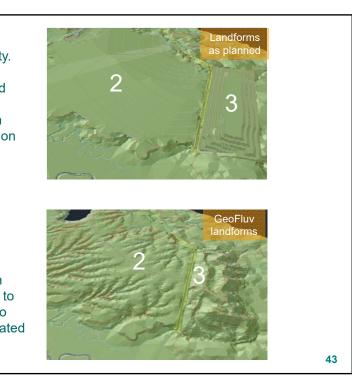
(2) The backfill grading buries the natural drainage pattern, losing hydrologic connectivity.

(3) The out-of-pit waste dump has a minimized disturbance footprint, but it is very unstable against erosion, provides minimal reclamation land use benefit, and is an <u>unsightly</u> monolith on the landscape.

(2) Establishing a fully functioning hydrologic system for the storm runoff, and restoring hydrologic connectivity was possible without extending the toe limits.

(3) The waste dump geomorphic rehabilitation has benefitted by extending its toe as needed to accommodate the volume of waste material, to convey storm water runoff without the accelerated erosion
