Catchment Water Quality Monitoring for Newcastle Wetland Connections (NWC)

Report 3:

December 2013 – December 2014

The Tom Farrell Institute for the Environment

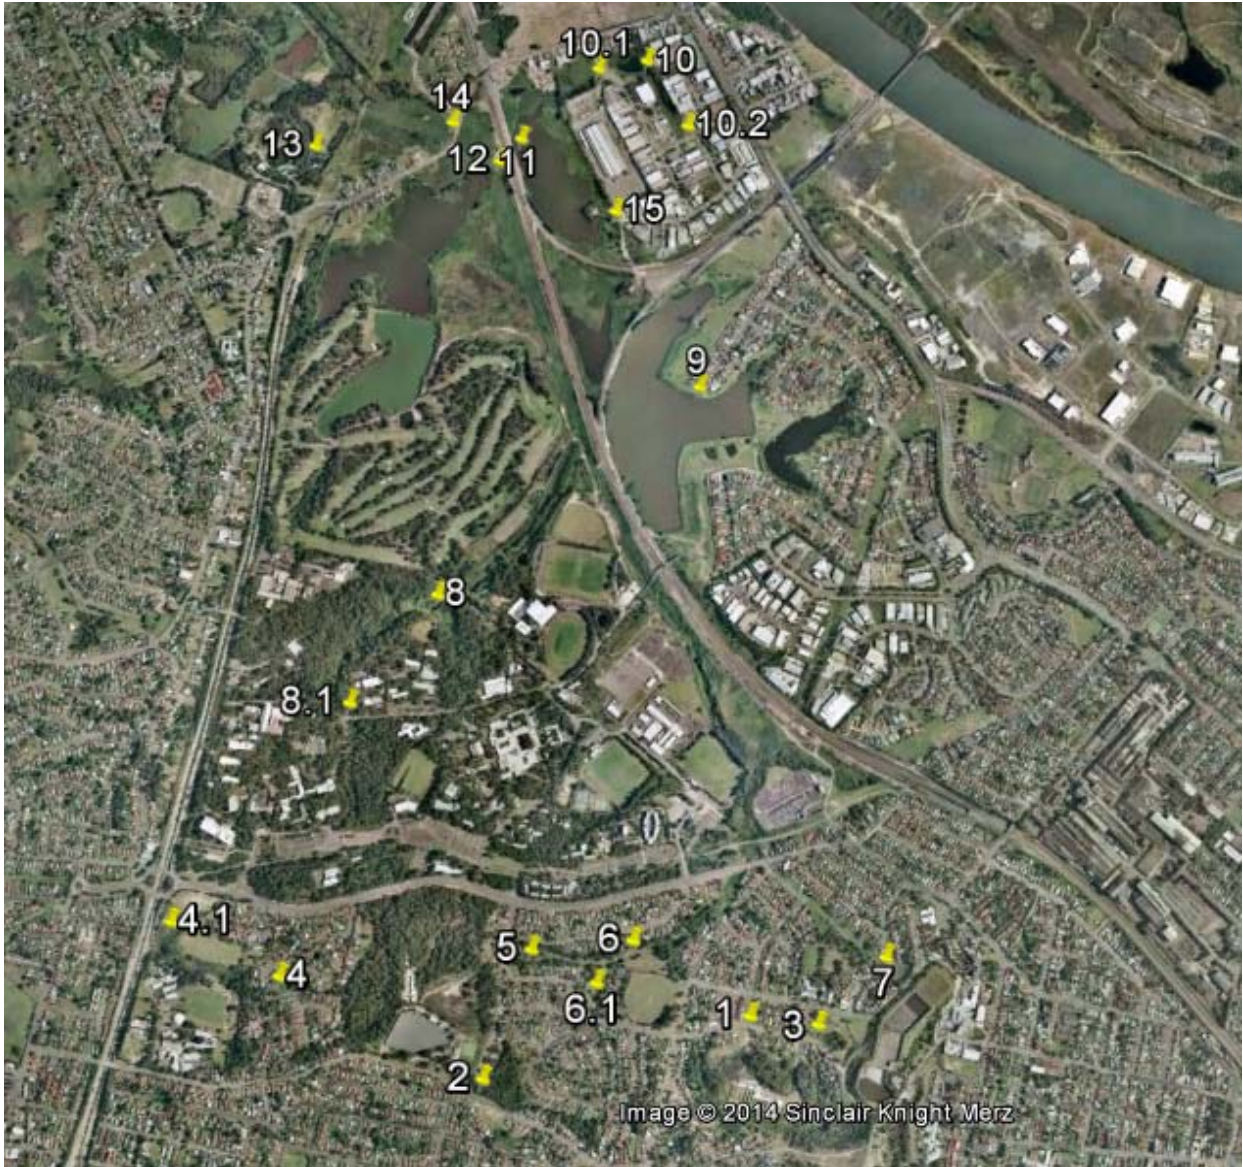
Figure 1: General location of water quality monitoring sites

Water quality site locations are shown in Figure 1. Note that the locations of these sites are likely to alter over the 4 year funding period as works are completed.

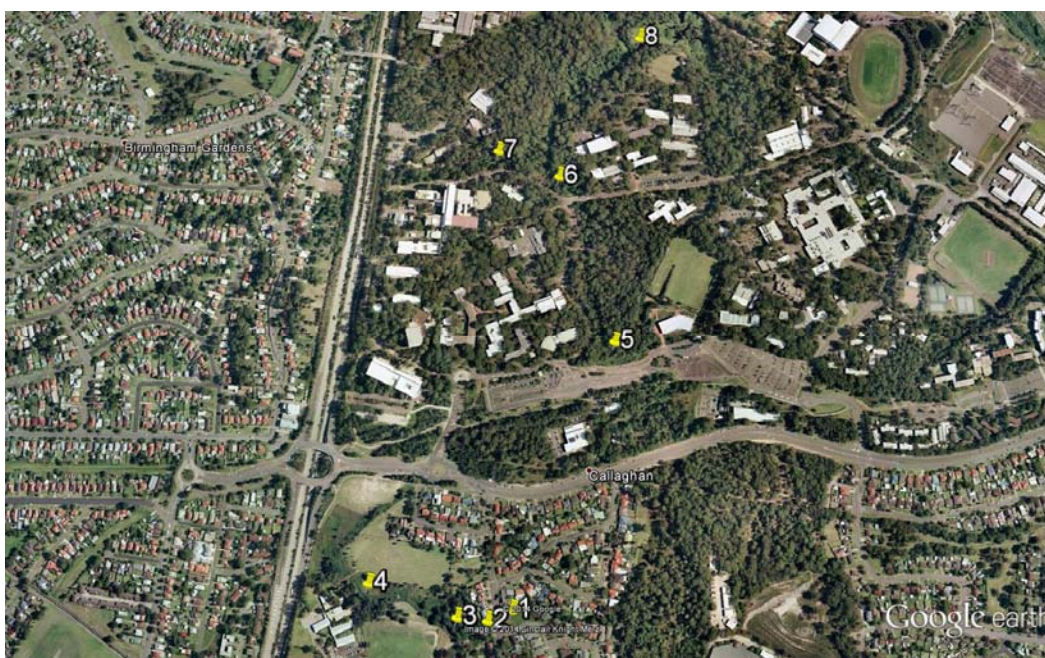
Figure 1: General location of water quality monitoring sites

Water quality monitoring sites undertaken in this study are shown in Figure 1. Note that the locations of these sampling sites may alter over the 4 year funding period as restoration works are completed within each catchment.

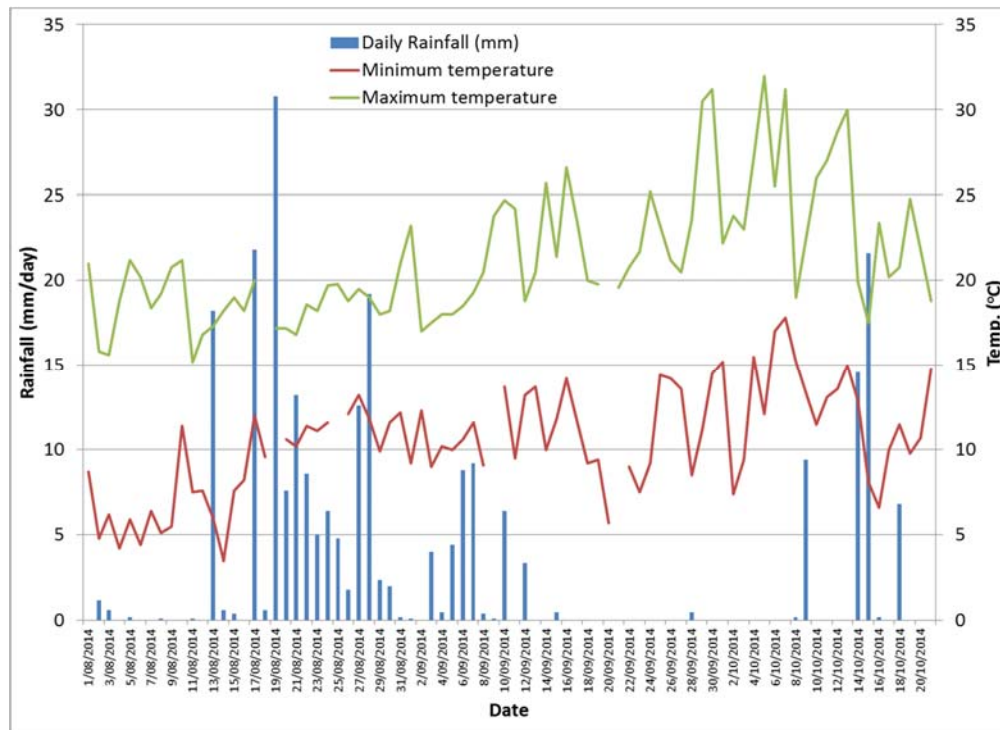
Figure 2: Daily rainfall and minimum/maximum temperature during the sampling period

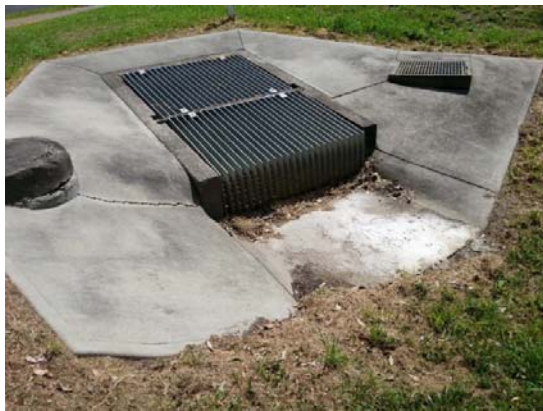
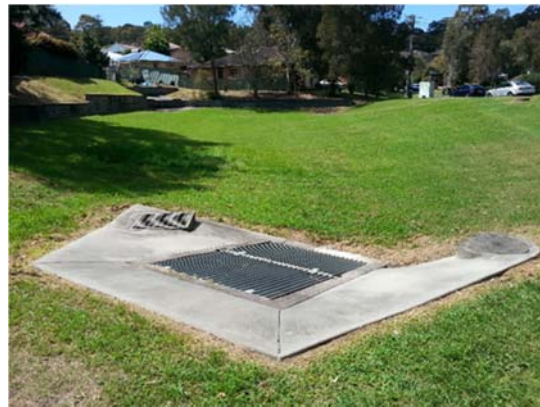
Description: Runoff from houses enters large grassed basin designed to allow infiltration of runoff. A coarse sediment trap is located at the lowest point allowing excess water to drain underneath Sunset Boulevard into Dark Creek.

Observations: Only three samples were collected at this site due to the infiltration properties of the grassed basin area. Significant extended rainfall events were needed to produce an amount of water large enough to sample. This site had no surface flow during the majority of the sampling events however subsurface flow was evident on all occasions indicated by the observed outflow into Dark Creek at site 2.

Sediment trap over drainage point

Grassy basin

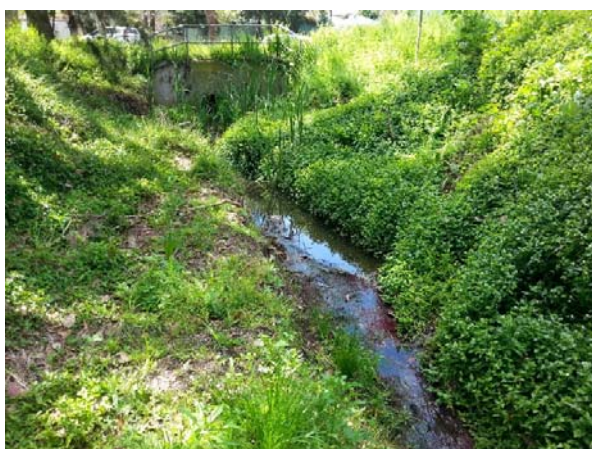
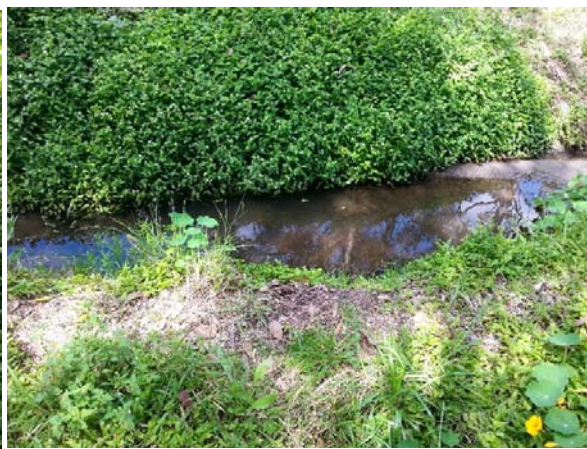
Observations: Substantial flow was recorded at this site on all sampling events even during dry conditions (baseflow). Milky colouration often observed.

Inflow to Site 2

Site 2 sample point

All parameters measured averaged within the ANZECC guidelines. Turbidity exceeded the recommended ANZECC guidelines on 2 occasions following significant rainfall reaching 70 NTU.

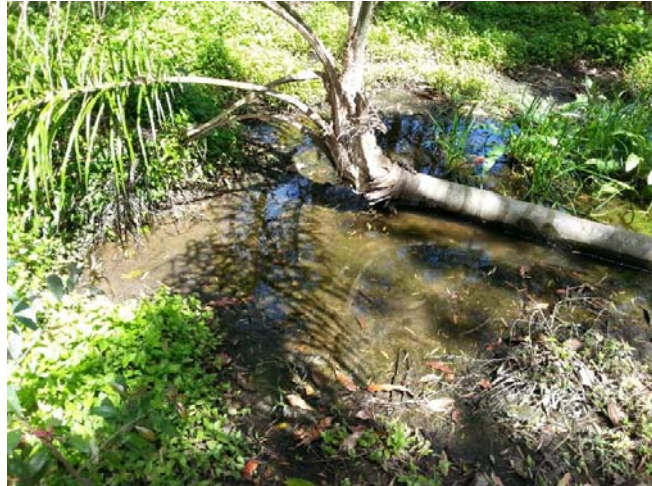
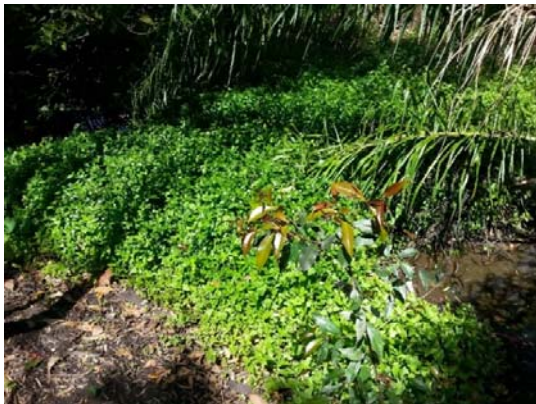
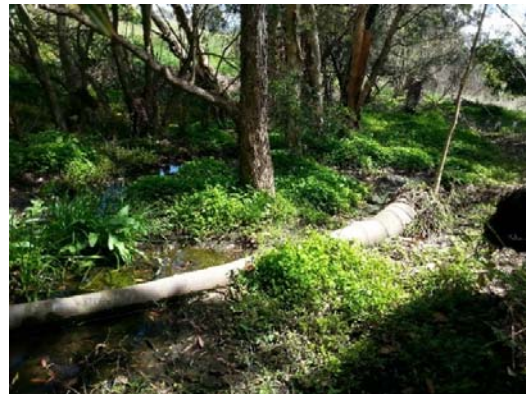
Observations: Flow more dispersed than Site 2 which leads to lower flow rate and increased standing time of water. Extensive ground vegetation conceals any obvious inflow.

Sample site 3

Vegetation cover concealing inflow

Large trees more prominent with outflow more dispersed

The DO at Site 3 averaged lower than the ANZECC recommended guidelines at 5.79 mg/L. Turbidity for Site 3 averaged within the ANZECC guidelines however following periods of significant rainfall it did exceed these guidelines reaching 61 NTU. All other parameters tested fell within the ANZECC guidelines.

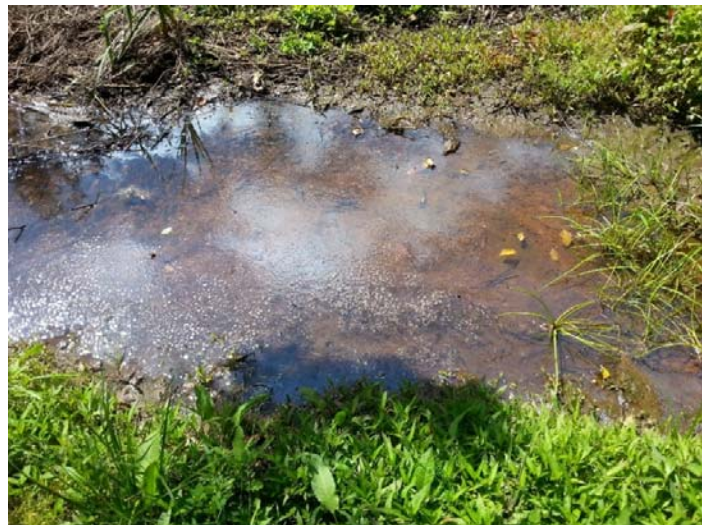
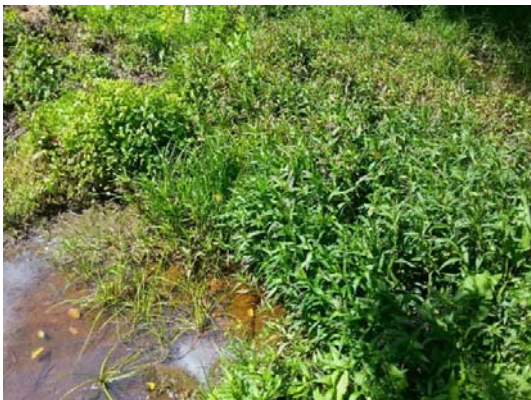
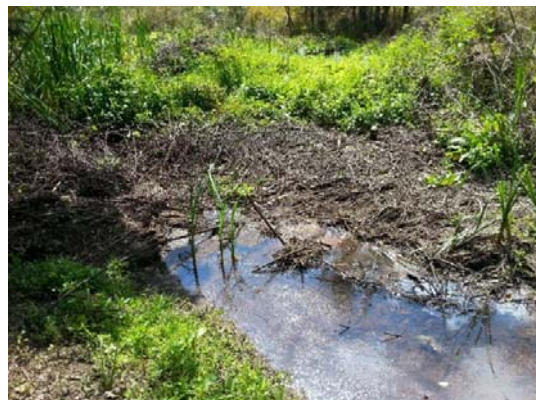
Observations: Little flow at all times (pooled). Substantial vegetation hinders flow and produces 'oily' film on surface of water (organics). Significant levels of debris has accumulated at outflow of sample site.

Sample Site 4

Inflow concealed by vegetation

Outflow with debris. Oily film clearly visible (organics)

As with Site 3, DO averaged slightly below ANZECC guidelines at 6.22 mg/L and turbidity averaged within the guidelines with a peak exceeding recommended levels during high rainfall periods reaching a 55 NTU maximum. pH and EC fell comfortably within the guidelines recommended by ANZECC.

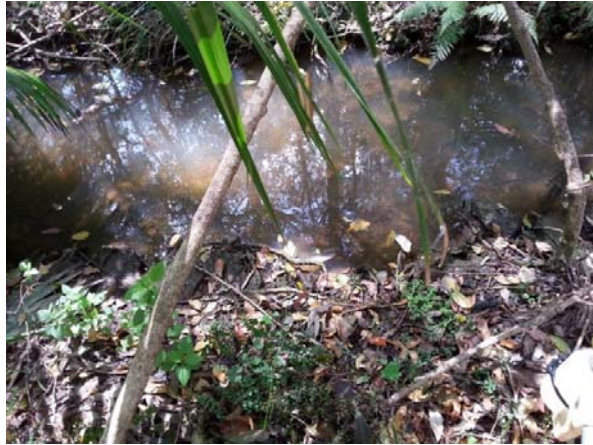
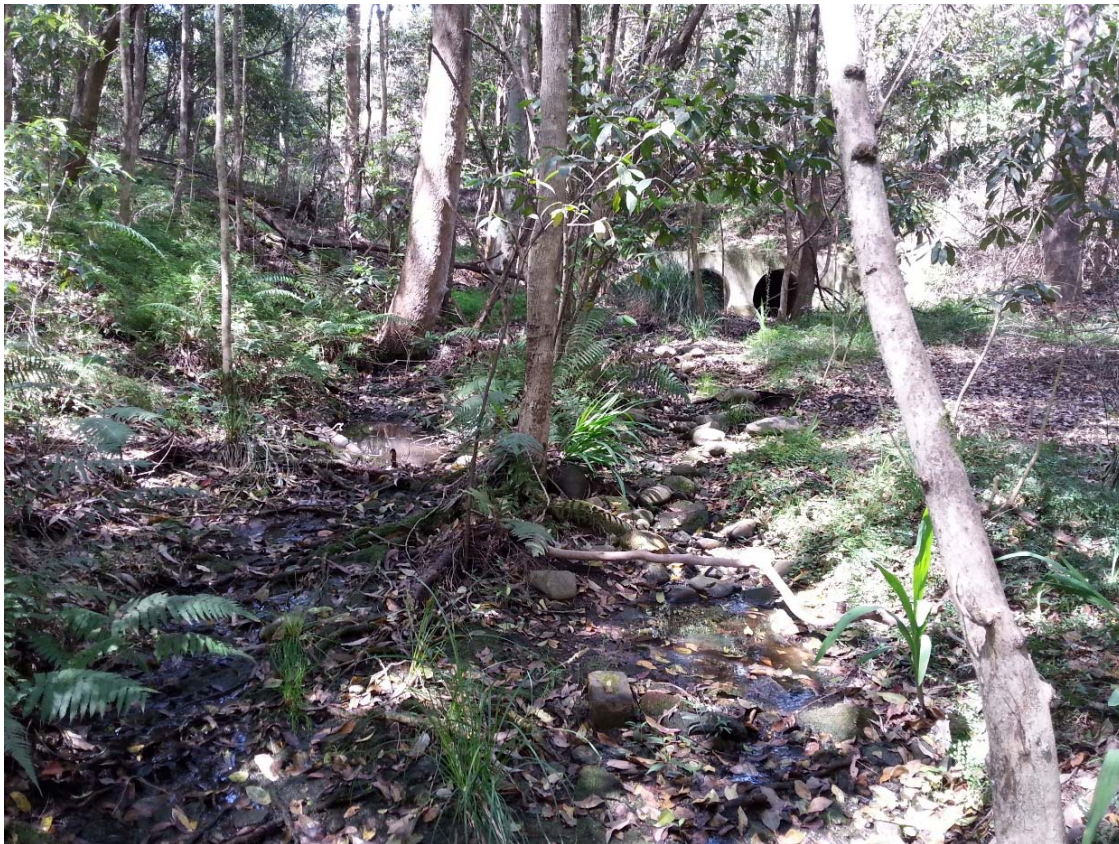
Observation: Combination of large trees and shrubby undergrowth. Creek contains larger stones in addition to a silty bed. Significant levels of leaf matter present in the water.

Sample site 5

Inflow with drain pipes clearly visible

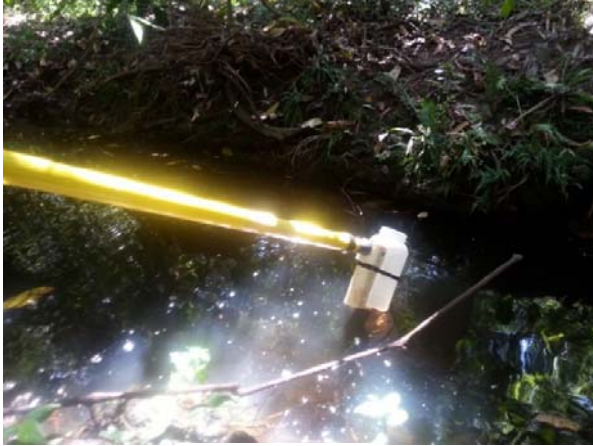
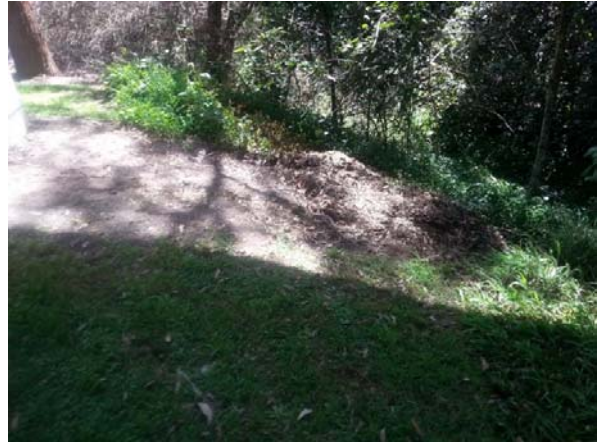
Observation: Similar vegetation to site 5 however with a more pronounced flow way. Evidence of grass clippings being dumped adjacent to site was observed with significant levels of sediment runoff possible.

Site 6

Grass clippings and leaf litter disposal leading to increased levels of sediment transfer and organic matter potentially entering creek

All measured parameters averaged within the ANZECC guidelines however DO fell below the recommended guidelines on three occasions falling to a minimum of 4.80 mg/L. Turbidity both exceeded and fell below the recommended range reaching a maximum of 55 NTU and a minimum of 5 NTU.

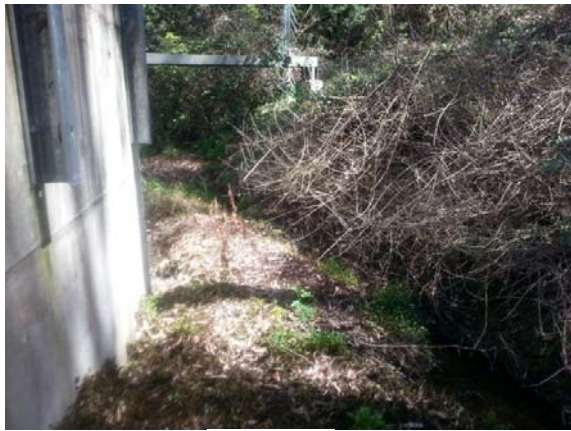
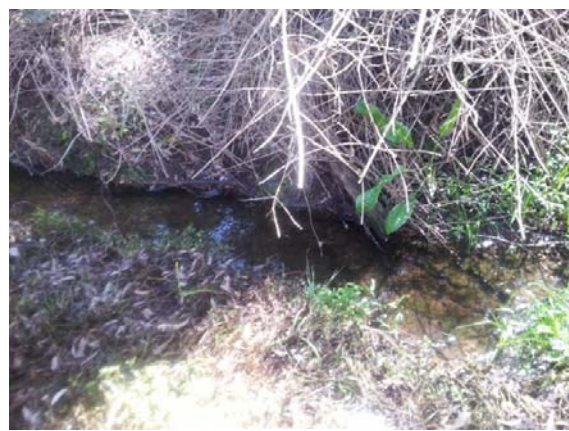
Observation: During periods of normal flow, flow path clearly identifiable. During periods of increased rainfall concrete structure becomes a wall channelling water downstream. This can be clearly seen by large amounts of leaf debris present on the edge of the flow path post large flow events.

Inflow

Site 7

EC and pH both fell comfortably within the ANZECC guidelines. pH fell just below the ANZECC guidelines on one occasion dipping to 6.30 and EC fell below the recommended ANZECC guidelines on a single occasion falling to 115 $\mu\text{S}/\text{cm}$. DO averaged below the typical range averaging 4.53 mg/L and reaching a minimum of 3.03 mg/L. DO was significantly lower on drier sample events. Turbidity averaged within the typical range recommended by ANZECC; and only once exceeding these levels (51 NTU) however fell below the recommended values on all but 3 occasions reaching a minimum of 2 NTU.

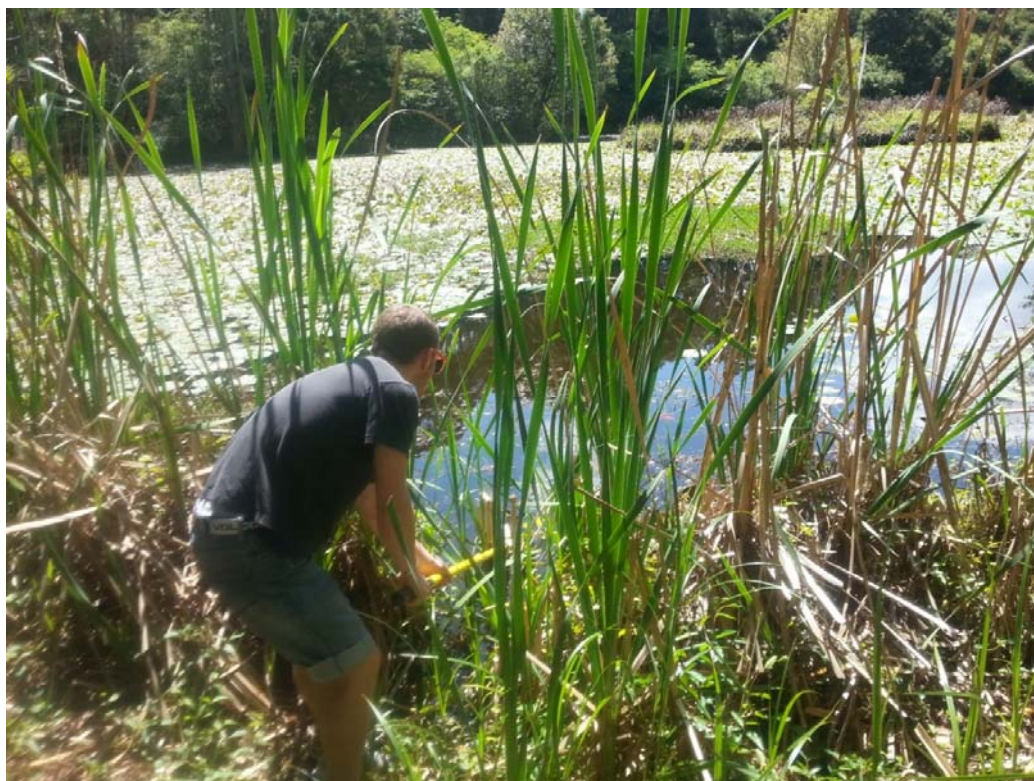
Observations: Reeds surround the perimeter of the swamp with vegetation present on the water surface. Bird life is abundant and the presence of fish in the swamp was noted.

Sampling at Site 8
